**Meeting of the
Reclamation District 2084
Board of Trustees
Thursday, November 2nd, 2023
8:30 am**

SUBJECT: November Engineer's Report

This letter presents a summary of our field observations, laboratory test results, and conclusions and recommendations regarding three seepage areas along the Reclamation District 2084 (District) levee adjacent to Cache Slough. The seepage areas are located at approximate District Stations 82+50 to 83+00, 214+50 to 220+00, and 276+00 to 278+00. The approximate locations of the seepage areas are presented on Figures 1 through 4.

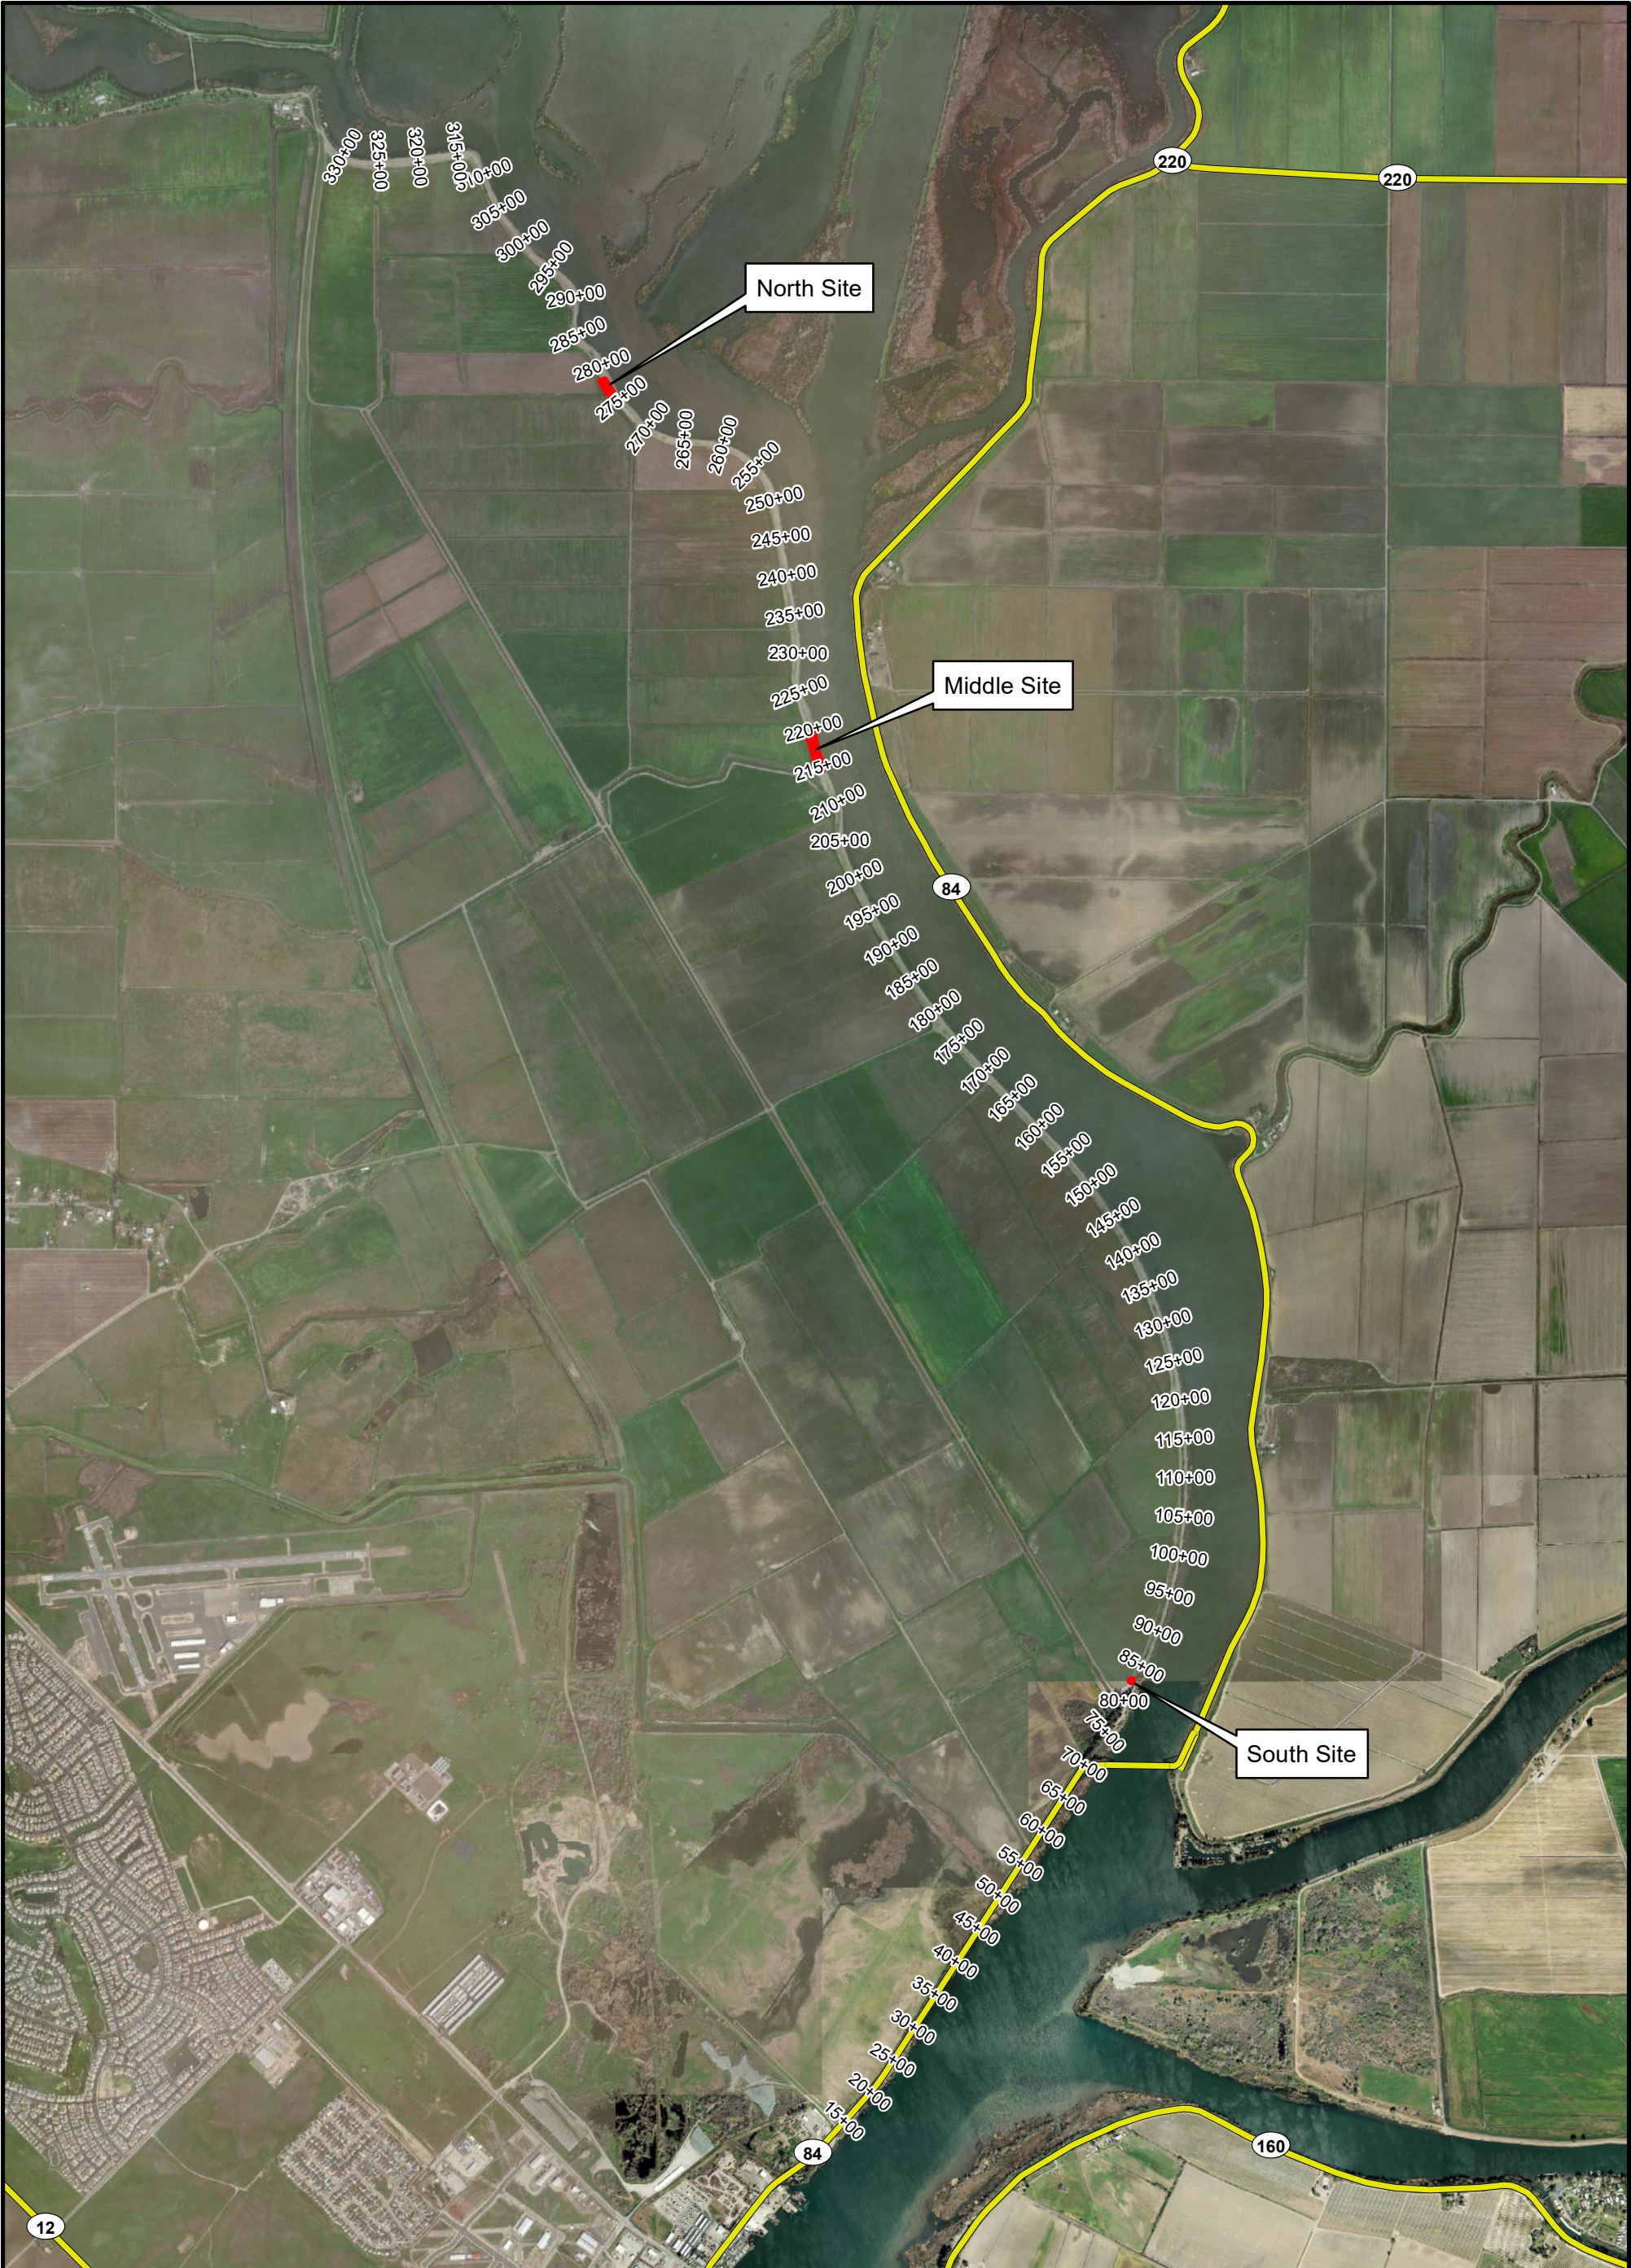
FIG. 1

Approximate Location of Seepage Area

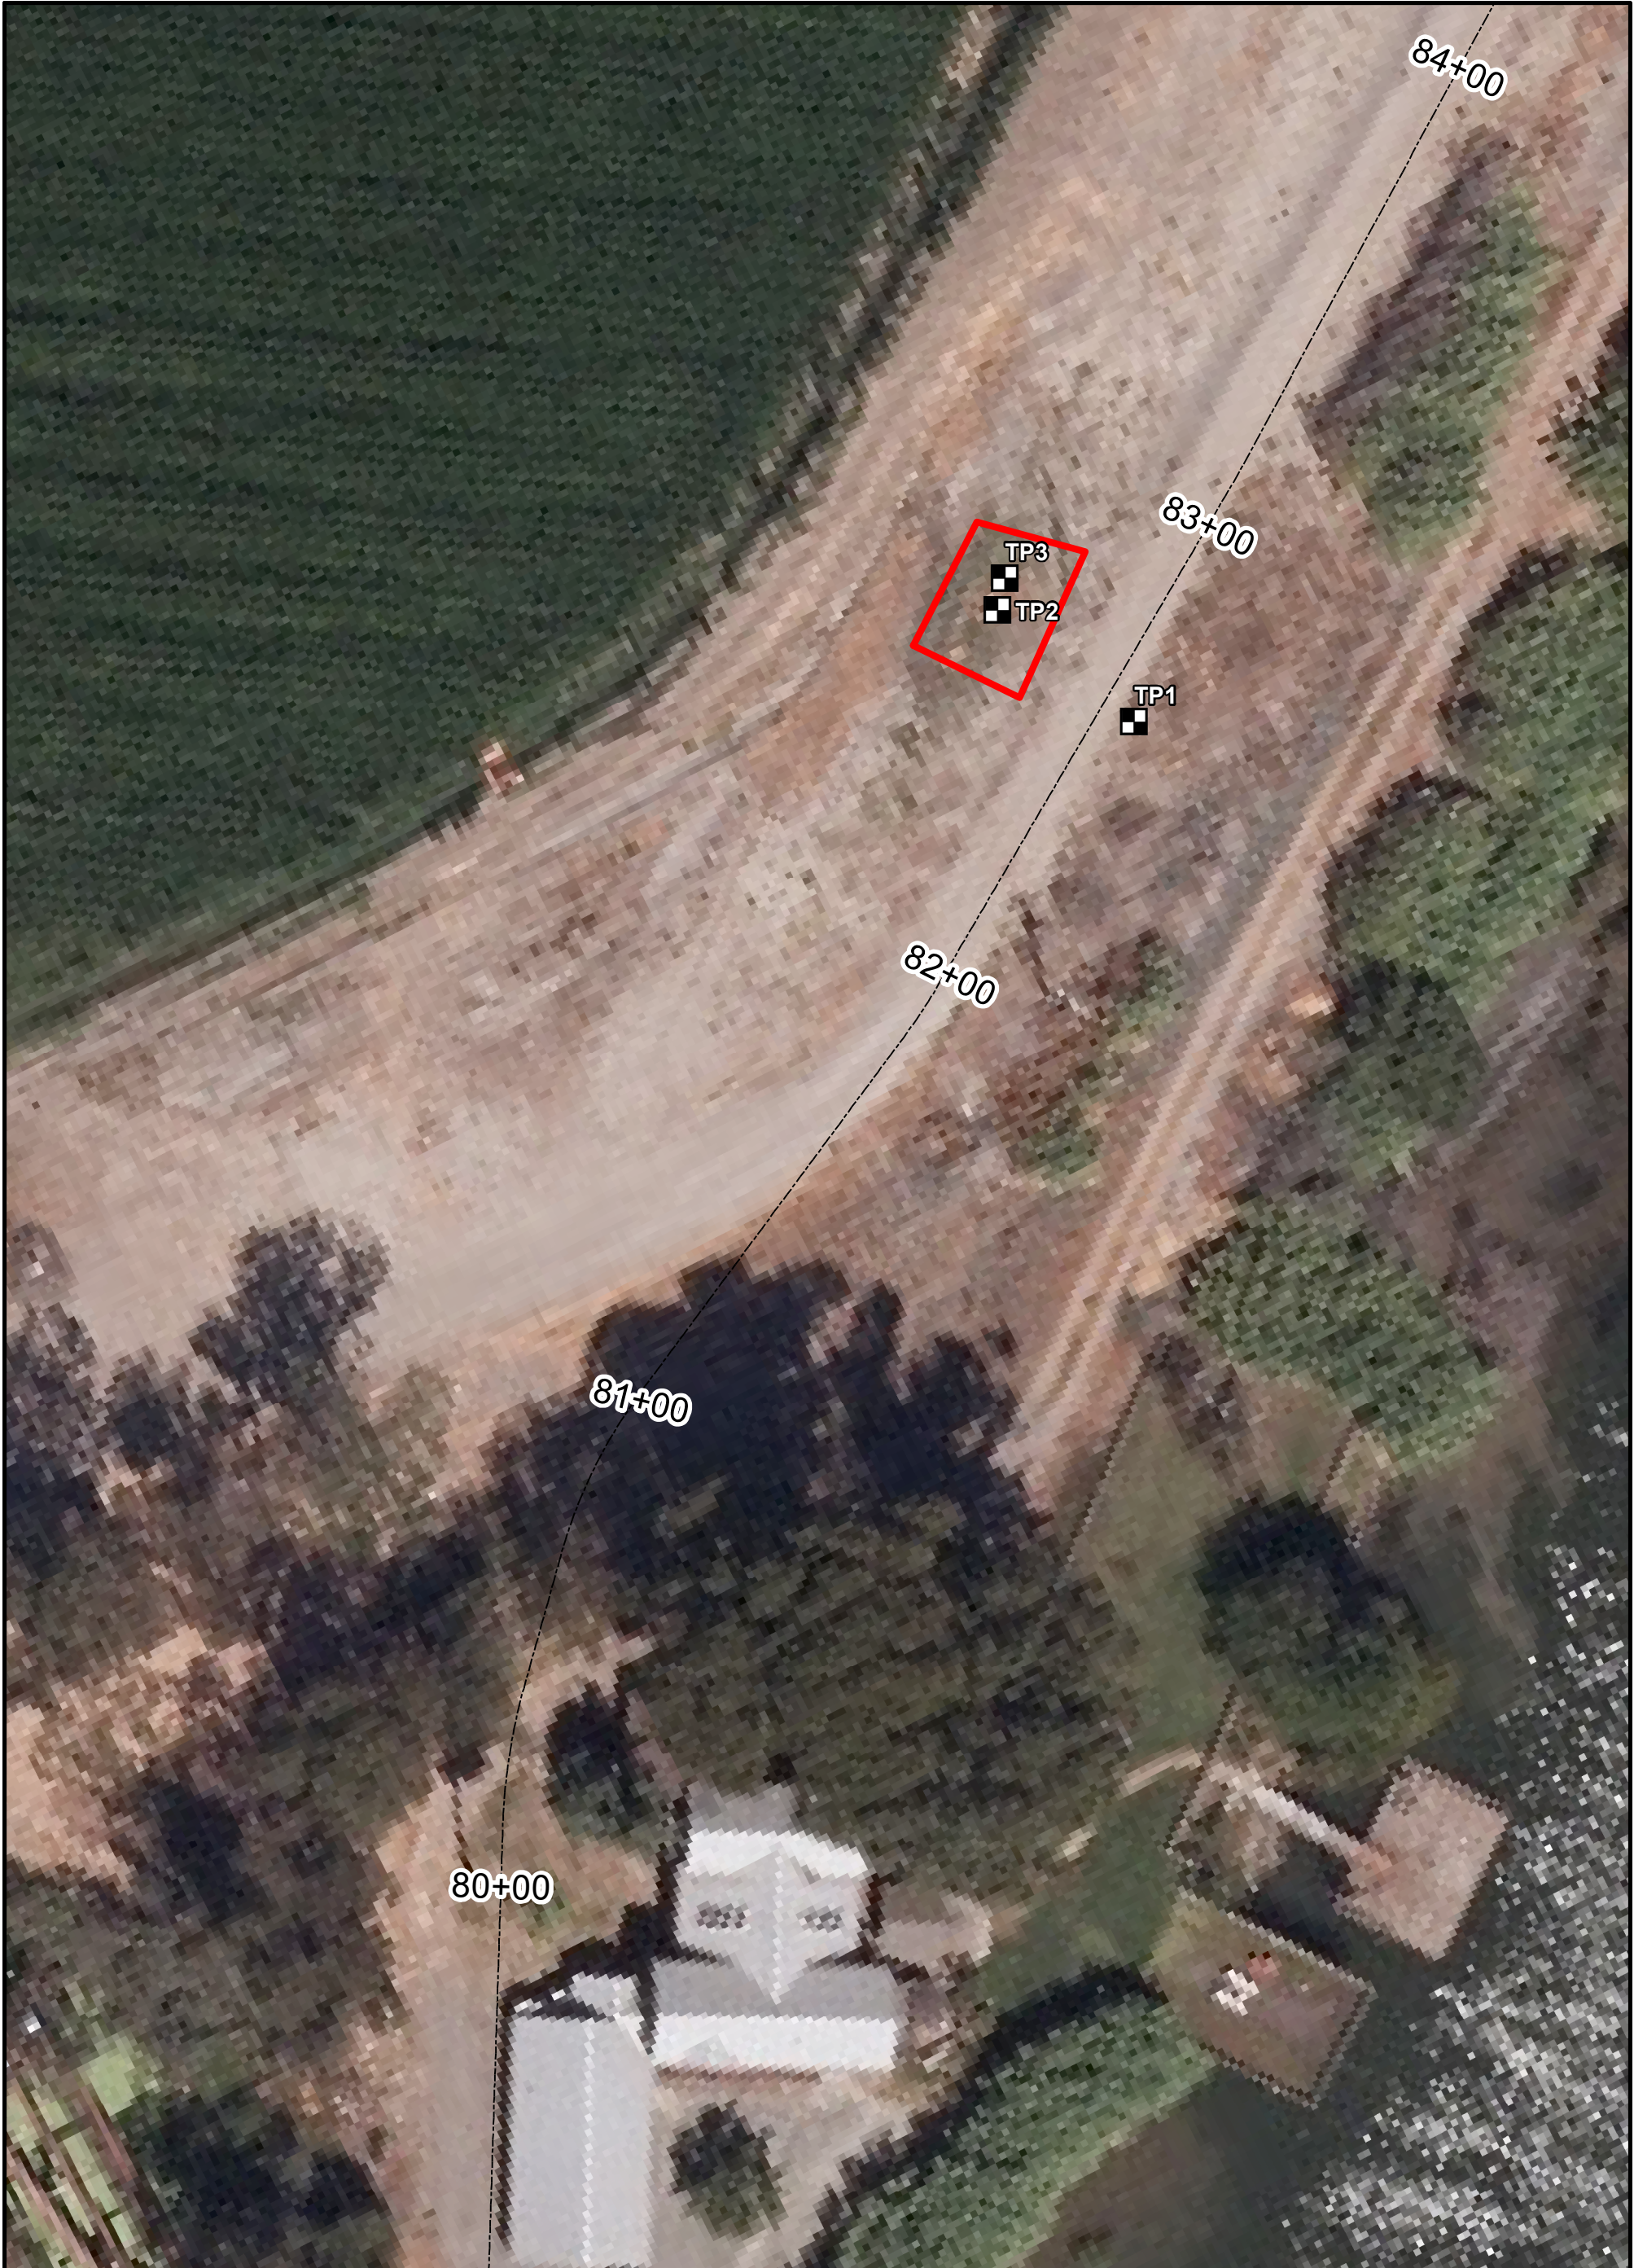
FIG. 2

At the north site, the levee crest elevation is approximately 15 feet, and the crest width is approximately 25 feet. An approximately 24-foot-wide ramp is located on the landside slope at approximately Elevation 3 feet. The inclination of the landside slope is approximately 3H:1V above the ramp and varies from approximately 2H:1V and 4H:1V below the ramp. The landside levee toe is at approximately Elevation -1.5 feet. Sandbag rings are present at the toe in locations where sand boils had previously been observed. We observed tules, puddles, and wet soil near the landside levee toe at the location indicated on Figure 2.

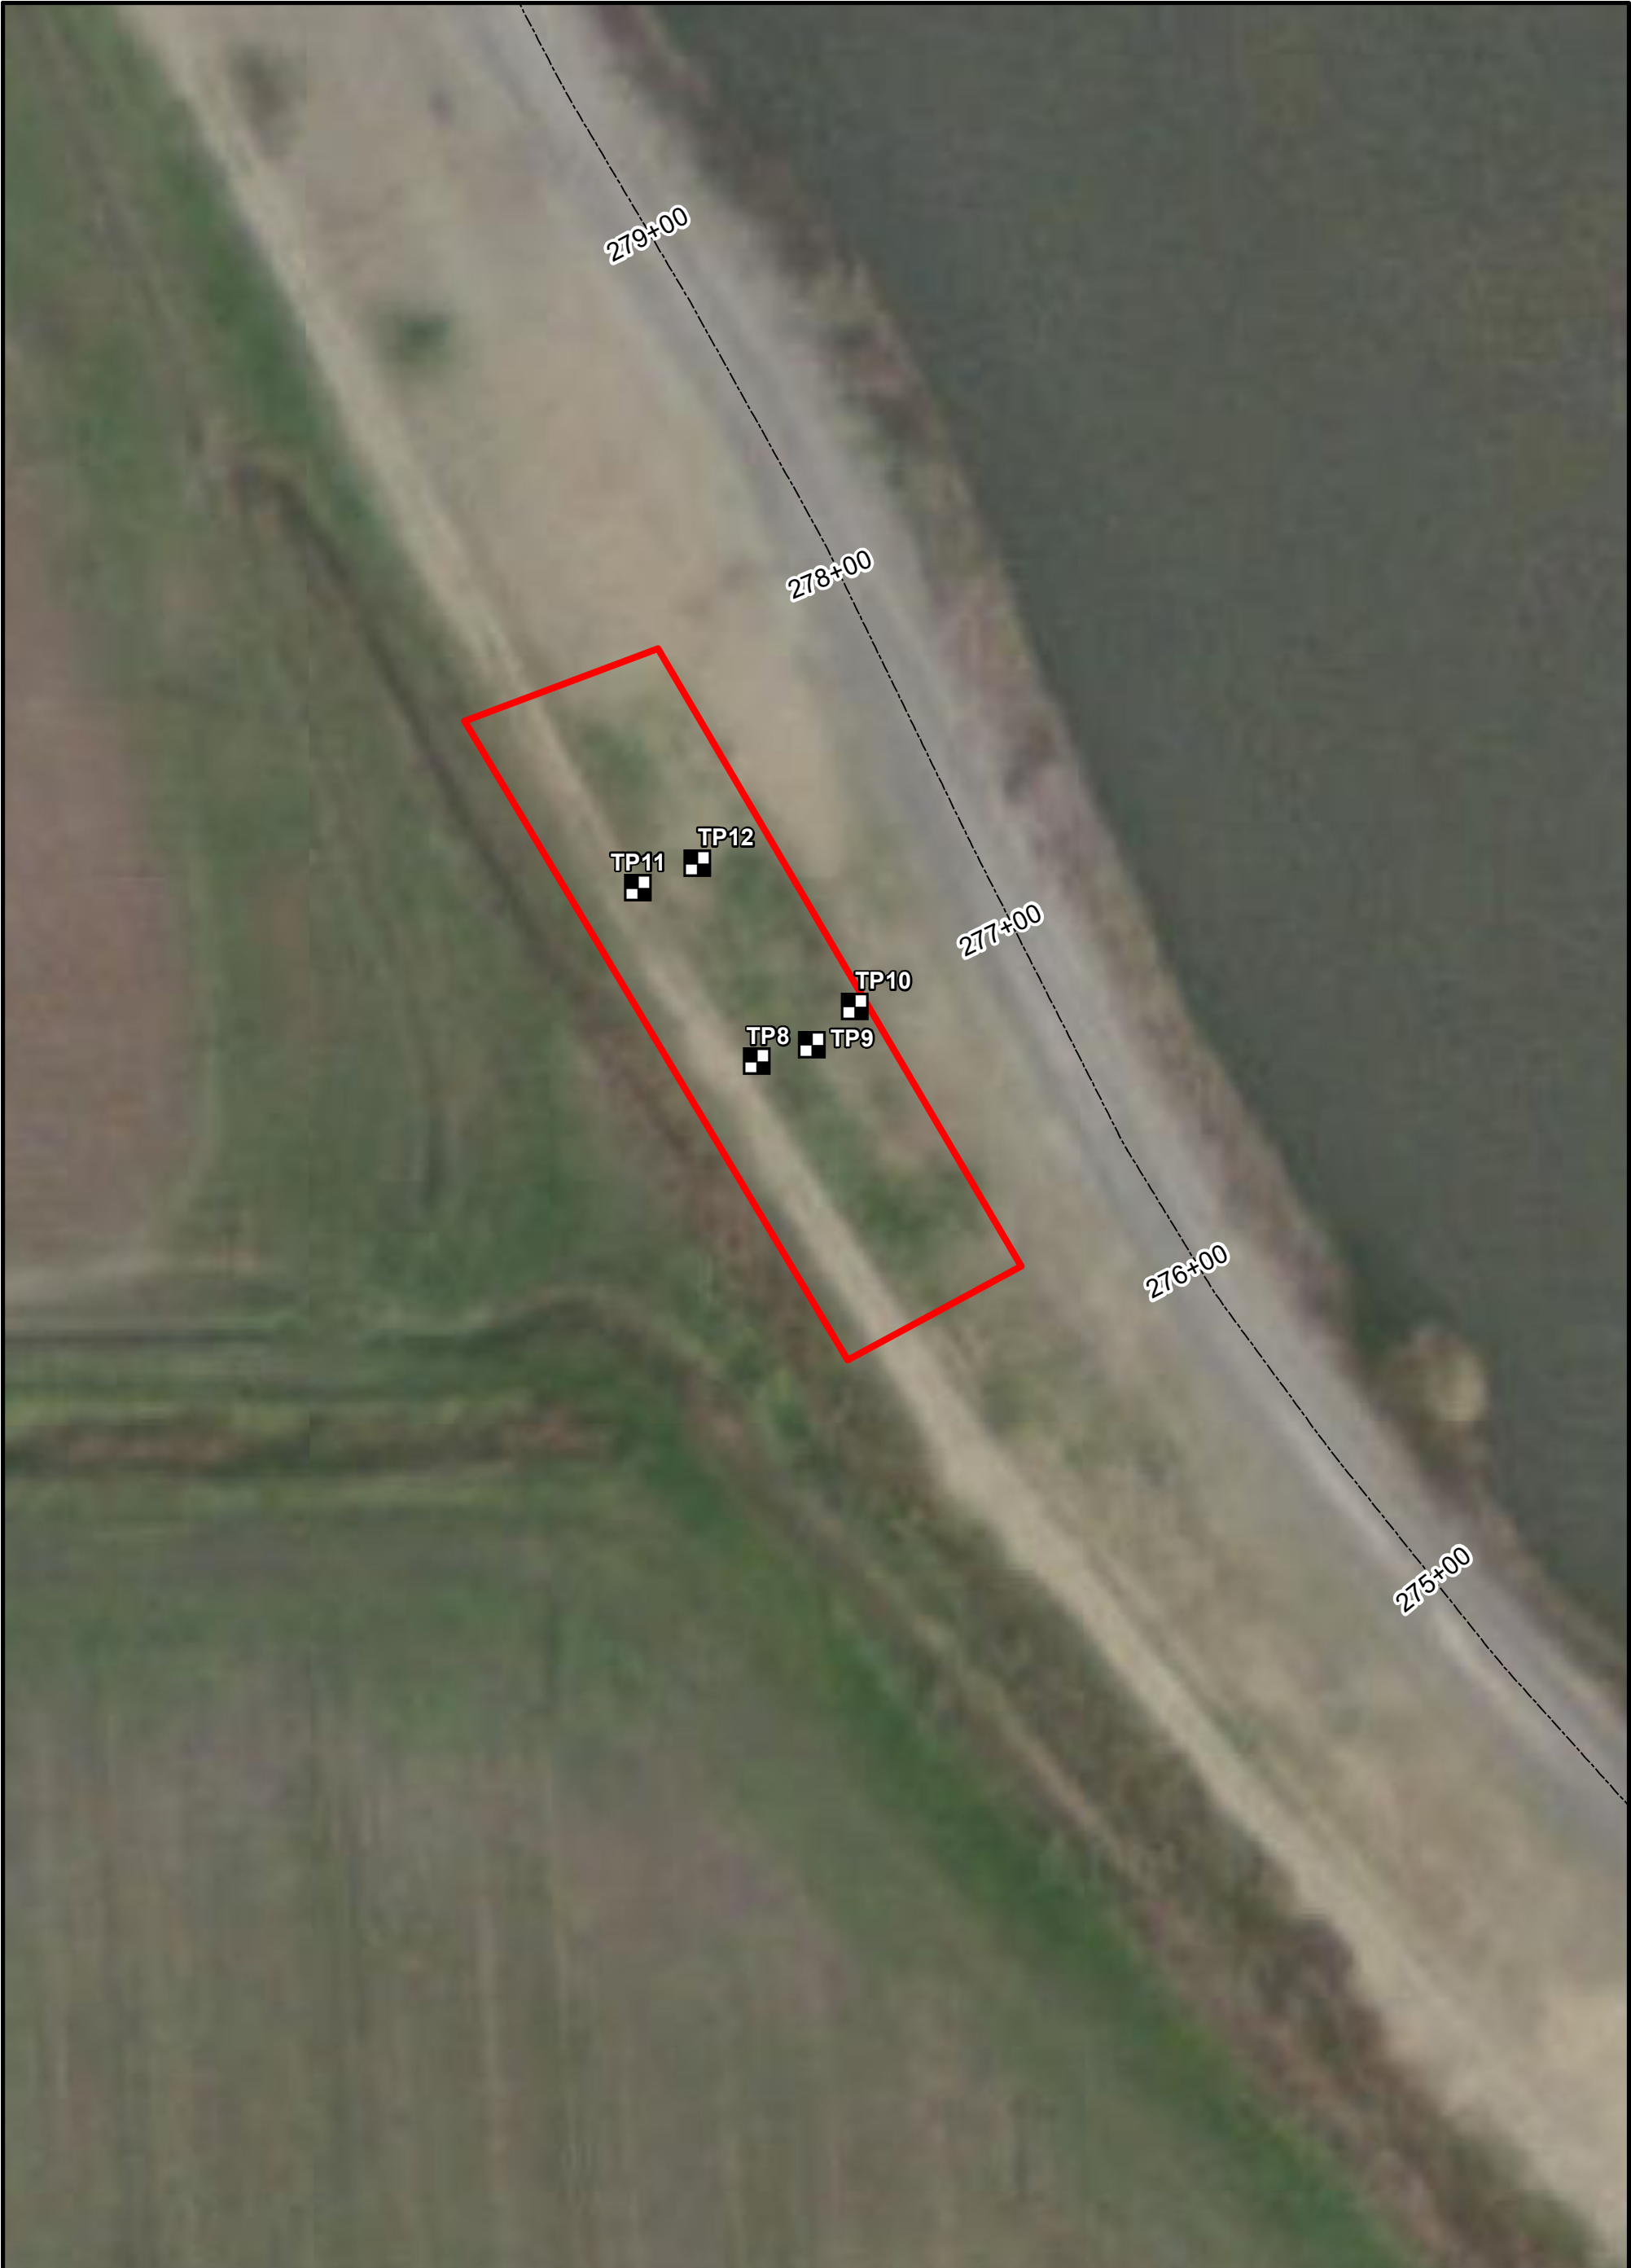
At the north site, the levee crest elevation is approximately 15 feet, and the crest width is approximately 24 feet. The inclination of the landside slope varies from approximately 3H:1V to 4.5H:1V. An unpaved road is cut into the landside levee toe at approximately Elevation -2.5 feet. The road is approximately 15 feet wide, and the vertical offset of the cut varies from 1 to 2 feet. We observed standing water on the ground surface on the toe road

<div><div><div></div><div>Approximate Location of Test Pit</div></div><div><div></div><div>Approximate Limits of Standing Water at Ground Surface</div></div><div><div></div><div>District Stationing Centerline</div></div></div>			<div>RD 2084 Seepage Areas Solano County, California</div>	
<div><div><div>N</div><div></div></div><div><div>0</div><div></div><div>40</div></div><div>Feet</div></div>			<div>SITE PLAN - NORTH SITE</div>	
			October 2023	112030
			<div><div></div>SHANNON & WILSON</div>	FIG. 4

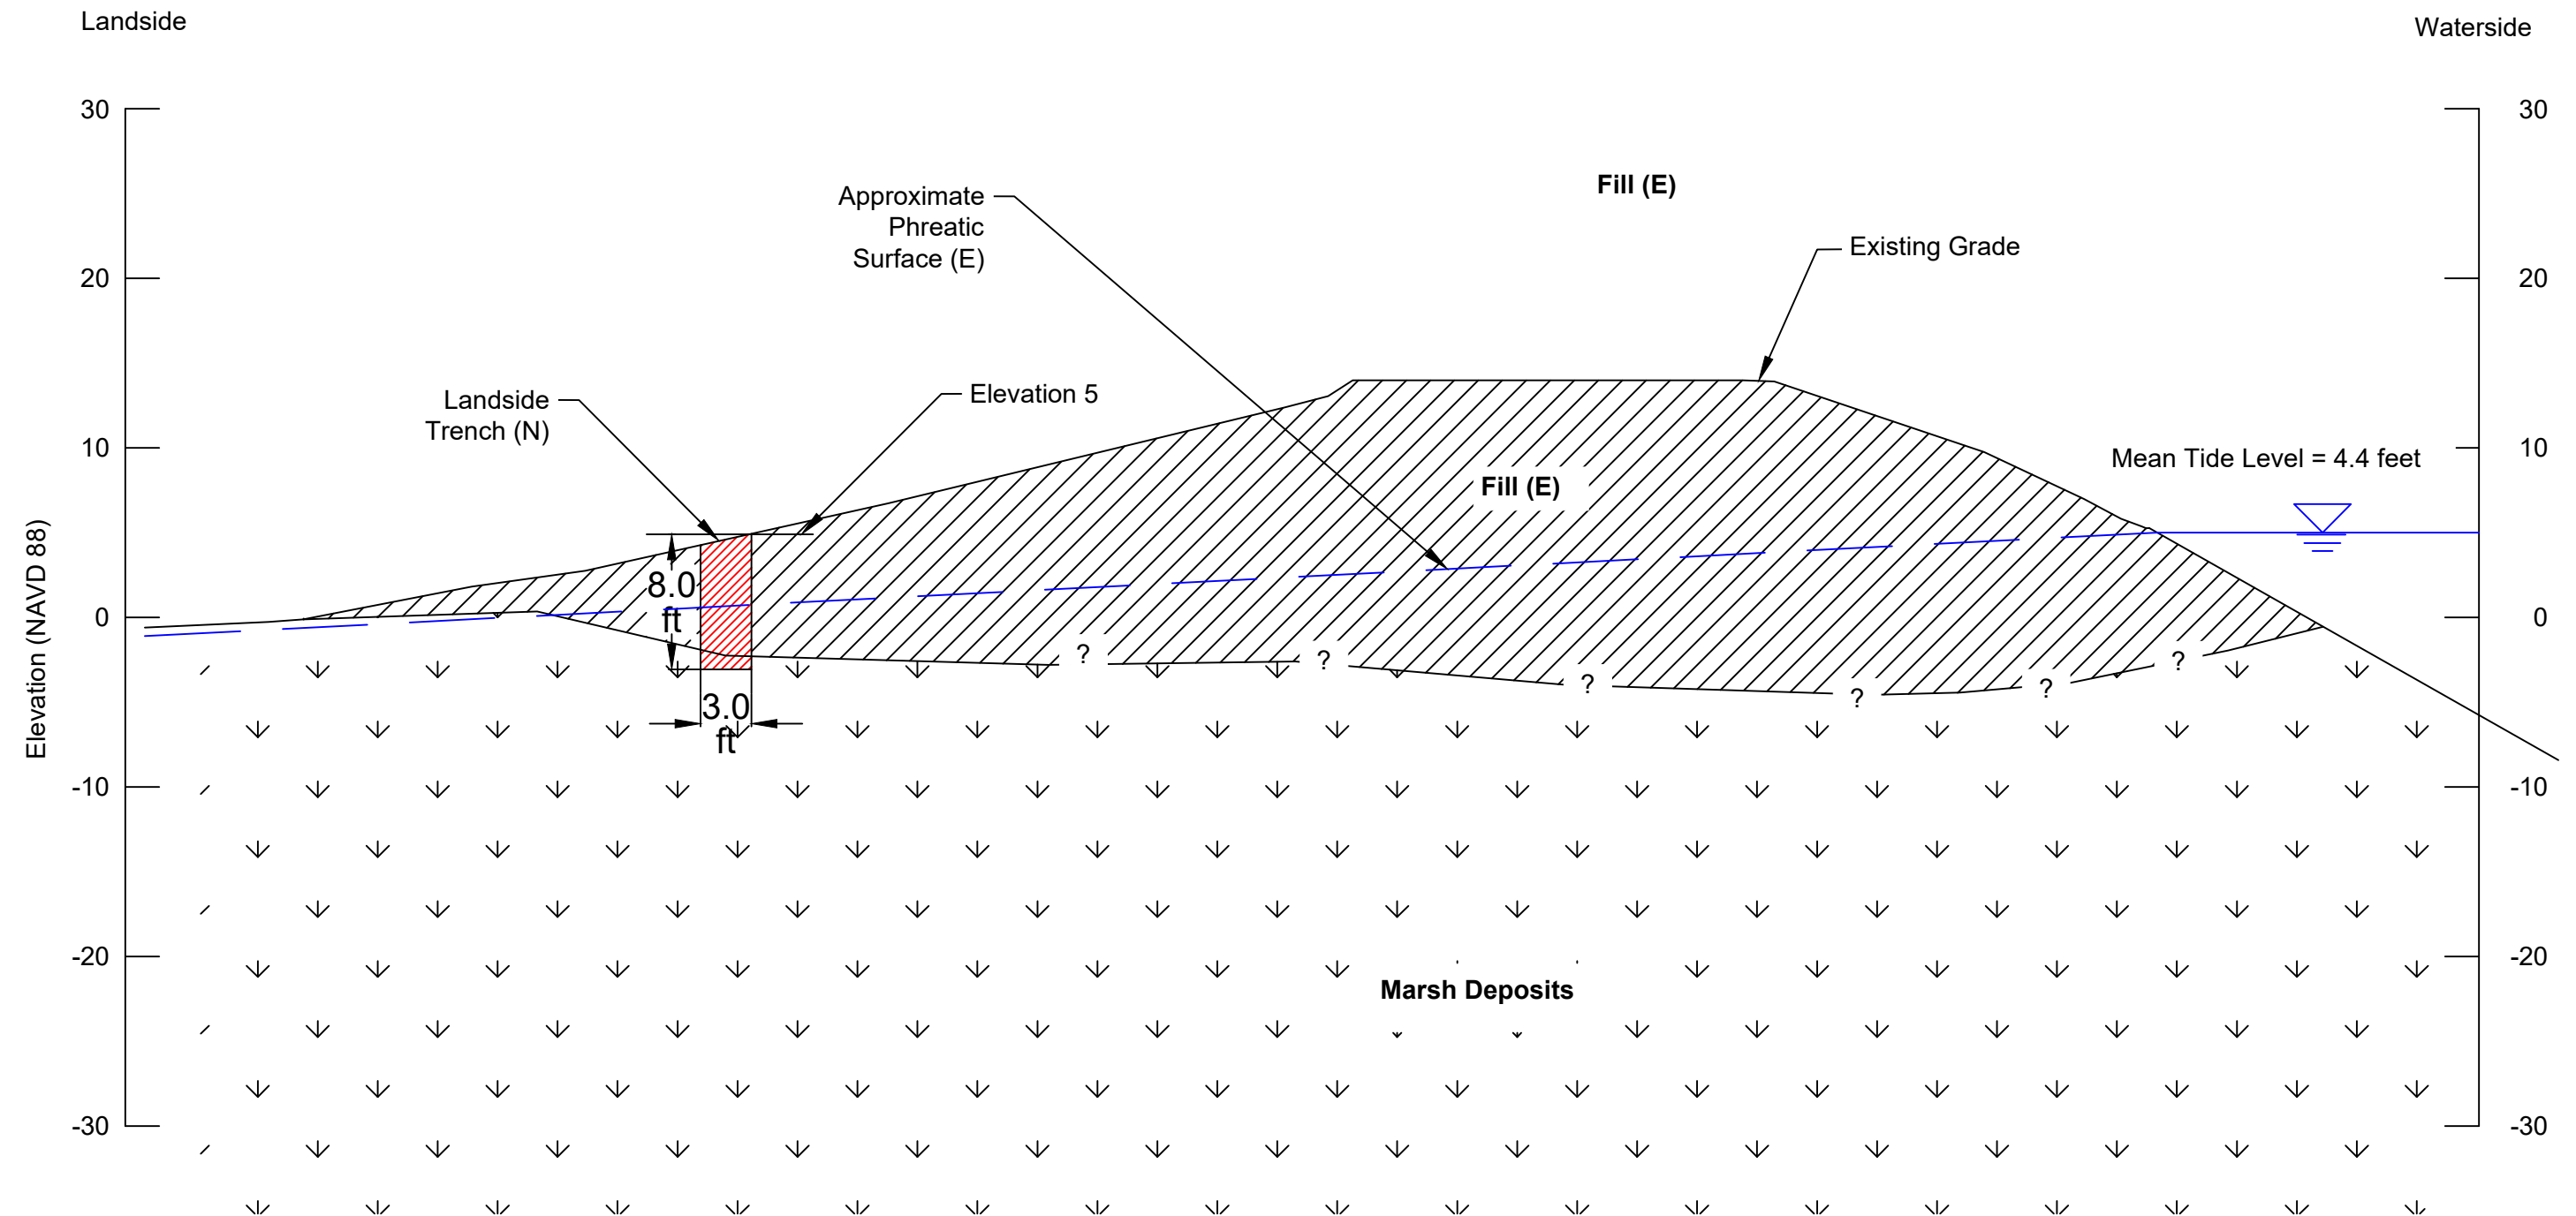
Water has been observed flowing from the landside levee slope near the levee toe on multiple occasions and we understand that the flow rate is greater during high water events. The water appears to be flowing through the levee near the interface of the embankment fill and the native soils at the middle and north sites. The path of water at the south site was not readily apparent from the test pits. The flow of water exiting the landside face and toe is undesirable. We conclude that remedial measures should be taken to reduce the seepage flowing through and beneath the levee. There are several options for interrupting or collecting the seepage flow with varying cost and reliability. We considered three options noted below.

Our recommended trench configuration is presented on Figure 5. The trench should be 3 feet wide. The top of the trench should be at or near Elevation 5 feet. The trench should extend at least 50 feet beyond observed seepage areas. The trench should extend as deep as practical without causing sloughing of the trench walls or extensive cracking of the levee crest adjacent to the trench. The depth of excavation should not exceed 8 feet unless authorized by us during construction. Excavated spoils may be used to backfill the exploratory trench. Backfilled material should be placed and compacted with a sheepsfoot

compactor, such as a wheel adapter for the excavator. The material should be placed in lifts less than 12 inches thick, moisture conditioned to at least optimum moisture content, and compacted to at least 90 percent relative compaction. At no time should there be more than 25 feet of trench open.

1. Shallow cutoff trench shall be excavated starting from the mid slope (approx EL + 5 ft), extending 8 feet deep.
2. Final configuration to be adjusted during construction.
3. Trench should extend through the fill into the native material.
